# Manhole Inspection Summary

Manhole # S35SS\_026MH

**Location** Address: **2701 SAINT PAUL ST**

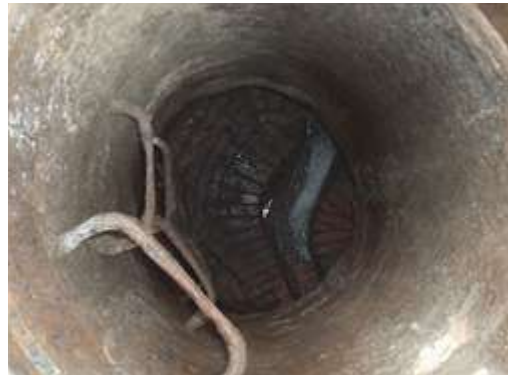
Top View

☒ **Debris** (not Condition related)

☒ **Corroded**

Corroded steps. Bench debris.

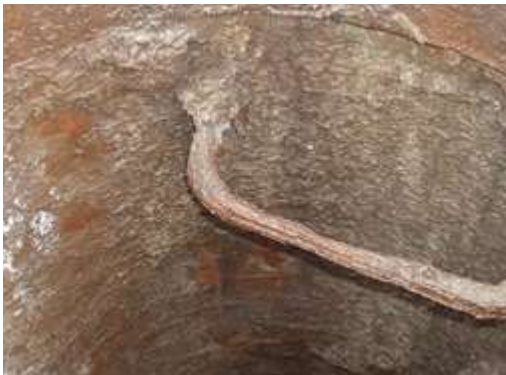
Defect

☒ **Leaks**

Infiltration: ☐ None ☒ **Joint** ☐ Cracks ☐ Mortar ☐ Roots ☒ **Wall**

Frame leaks. Adjustment infiltration.

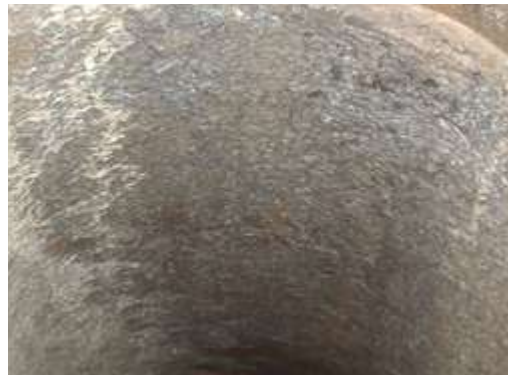
Defect

Frame leaks. Adjustment infiltration.

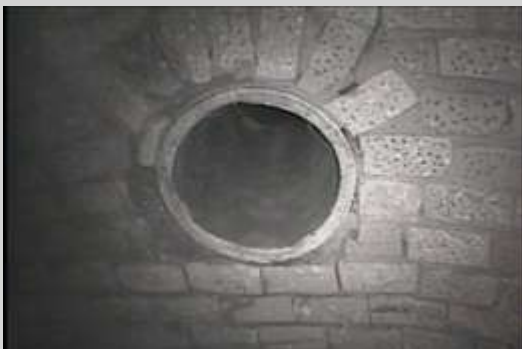
### 8 in. Circular Gravity Sewer Pipe In @ 6 O'Clock

Infiltration: **Evidence** Pipe Seal Cond: **Unknown**
